# Manhole Inspection Summary

# Manhole # S09WW1012MH

Insp Date: **10/18/06 11:55 AM**

**Location** Address: **5504 WOODCREST AVE**

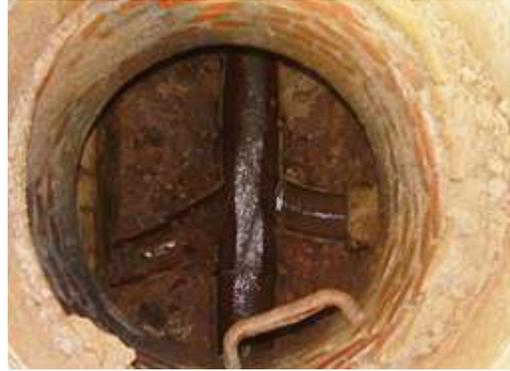
Top View

Corroded steps. Bench debris.

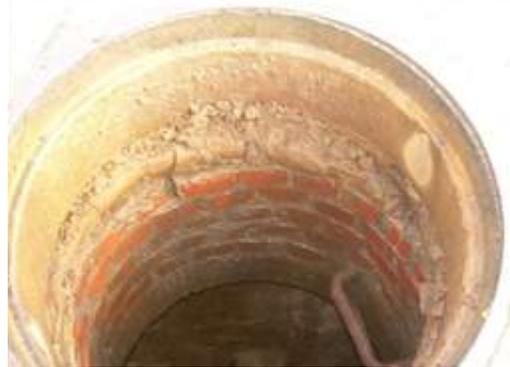
Defect

Frame leaks. Frame offset. Corroded step. Adjustment deterioration and infiltration. Corbel and Barrel infiltration.

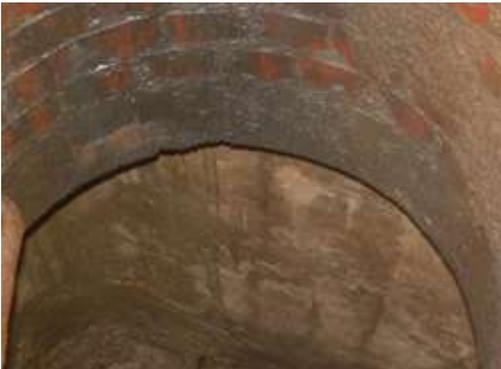
Defect

Corbel and Barrel infiltration.

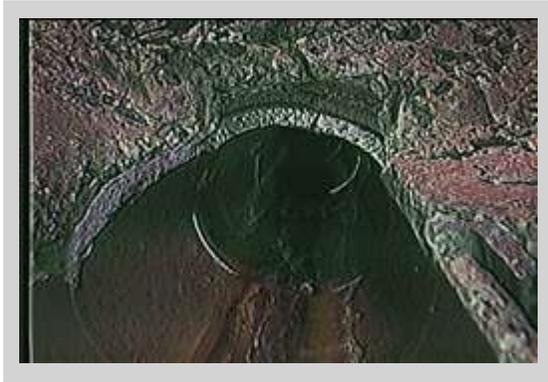
## 8 in. Circular Gravity Sewer Pipe Out @ 12 O'Clock

Barrel deterioration and infiltration. Channel cracks.

Infiltration: **Evidence** Pipe Seal Cond: **Cracked**

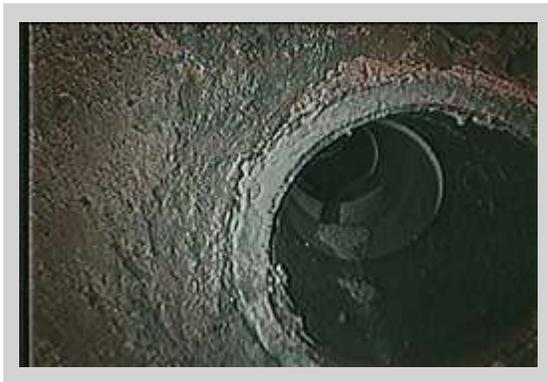
## 8 in. Circular Gravity Sewer Pipe In @ 3 O'Clock

Infiltration: **Evidence** Pipe Seal Cond: **Cracked**

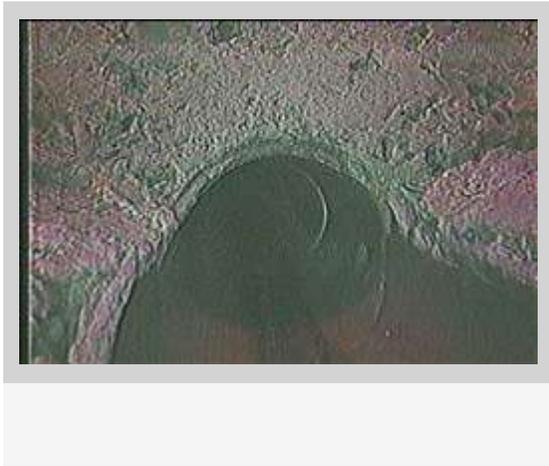
Pipe In @ 6 O'Clock

Infiltration: **Evidence** Pipe Seal Cond: **Cracked**
